Study on the Behavior of Pile Cap Model with Various Type Failure of Concrete Cap

*Ambareesh Kumar
 Dept. of Civil Engineering,
 M.M.M. Engineering College,
 Gorakhpur, India.
 Email: ambar006@gmail.com

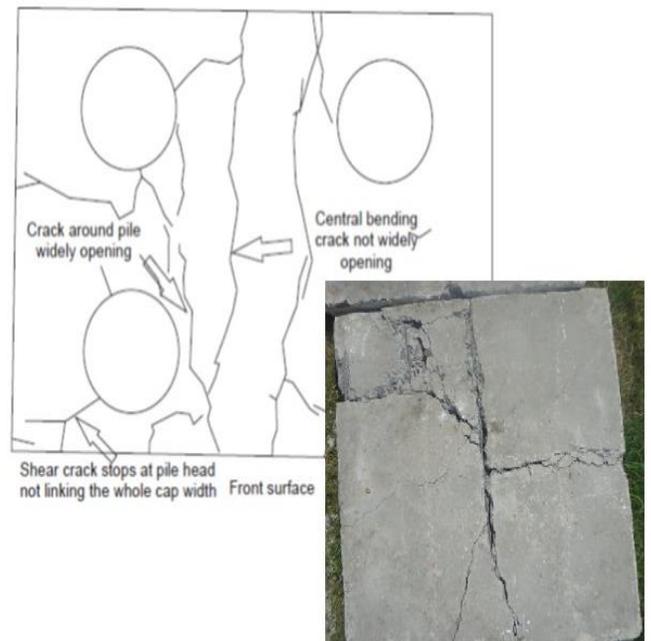
Figure-6 Crack distribution on PC-1C cap soffit at failure step

The bending crack and the critical shear crack matured rapidly one after the other with both opening widely, but one finally overwhelming the other. Apart from PC-1C (shear failure without any significant bending crack on front surface (Figure-6) and PC-3C (bending failure without any significant shear crack on back surface (Figure-10), bending failure and shear failure were always very close at the failure step.

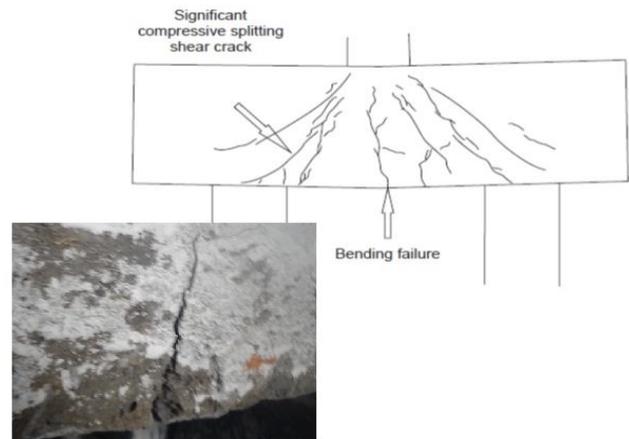
Figure-10 Crack distribution on PC-3C back surface at failure step

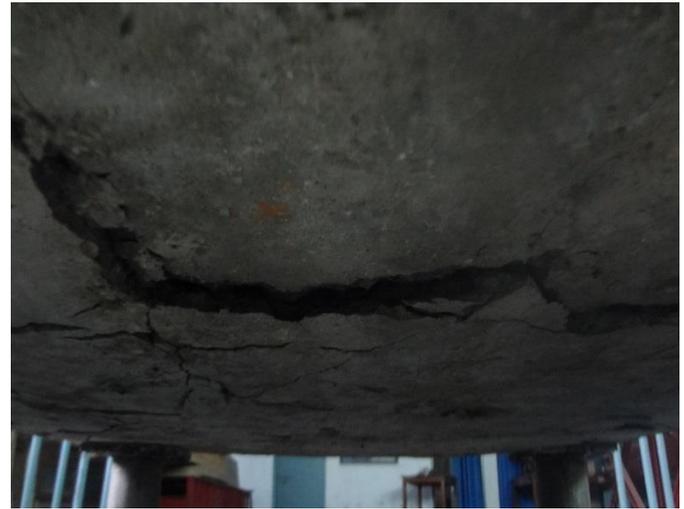
Figure-12 Observed crack pattern in experiment
